PB90-916405
NTSB/MAR-90/04

NATIONAL TRANSPORTATION SAFETY BOARD

MARINE ACCIDENT REPORT

GROUNDING OF
THE U.S. TANKSHIP EXXON VALDEZ
ON BLIGH REEF, PRINCE WILLIAM SOUND
NEAR VALDEZ, ALASKA
MARCH 24, 1989

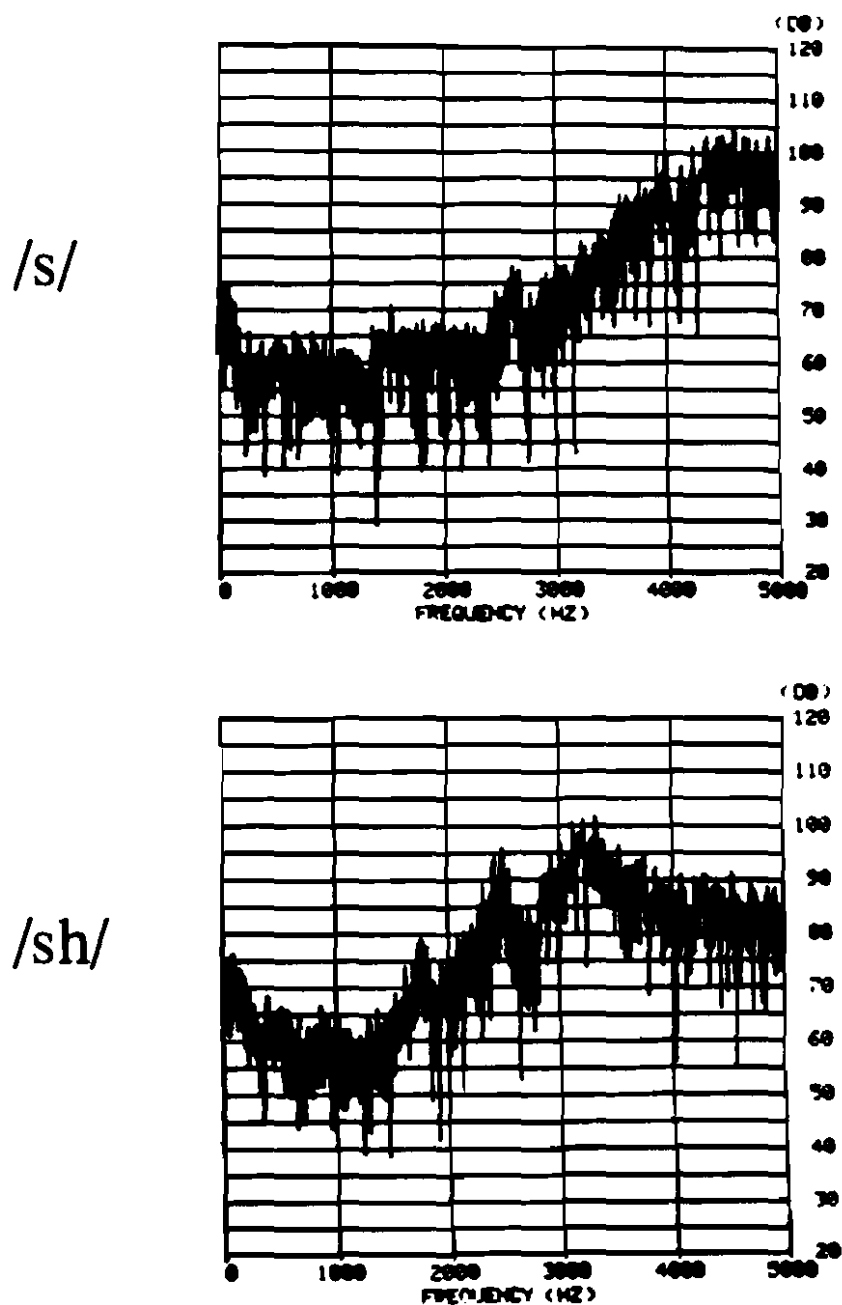
Figure 1. Power spectra of /s/ (top) and /sh/ (bottom) produced by KJ in a quiet recording booth with recording equipment responsive up to 5000 Hz.

Figure 1 shows power spectra of /s/ and /sh/ produced by the first author (KJ). The horizontal axis in these graphs shows frequency from 0 to 5000 Hz and the vertical axis shows amplitude in decibels. Many speech sounds (including /s/ and /sh/) can be distinguished by their amplitude spectra because they have differing amounts of energy at different frequencies. In particular, /s/ is characterized by a peak of energy in the range from 4000 to 5000 Hz, while /sh/ has a lower frequency peak (in the range from 3000 to 4000 Hz) and a lower amplitude peak of energy in the range from 2000 to 3000 Hz. The spectra in Figure 1 illustrate what the power spectra of /s/ and /sh/ look like in recordings which have a high signal-to-noise ratio and frequency information up to 5000 Hz (see also Borden and Harris, 1984, p. 189).

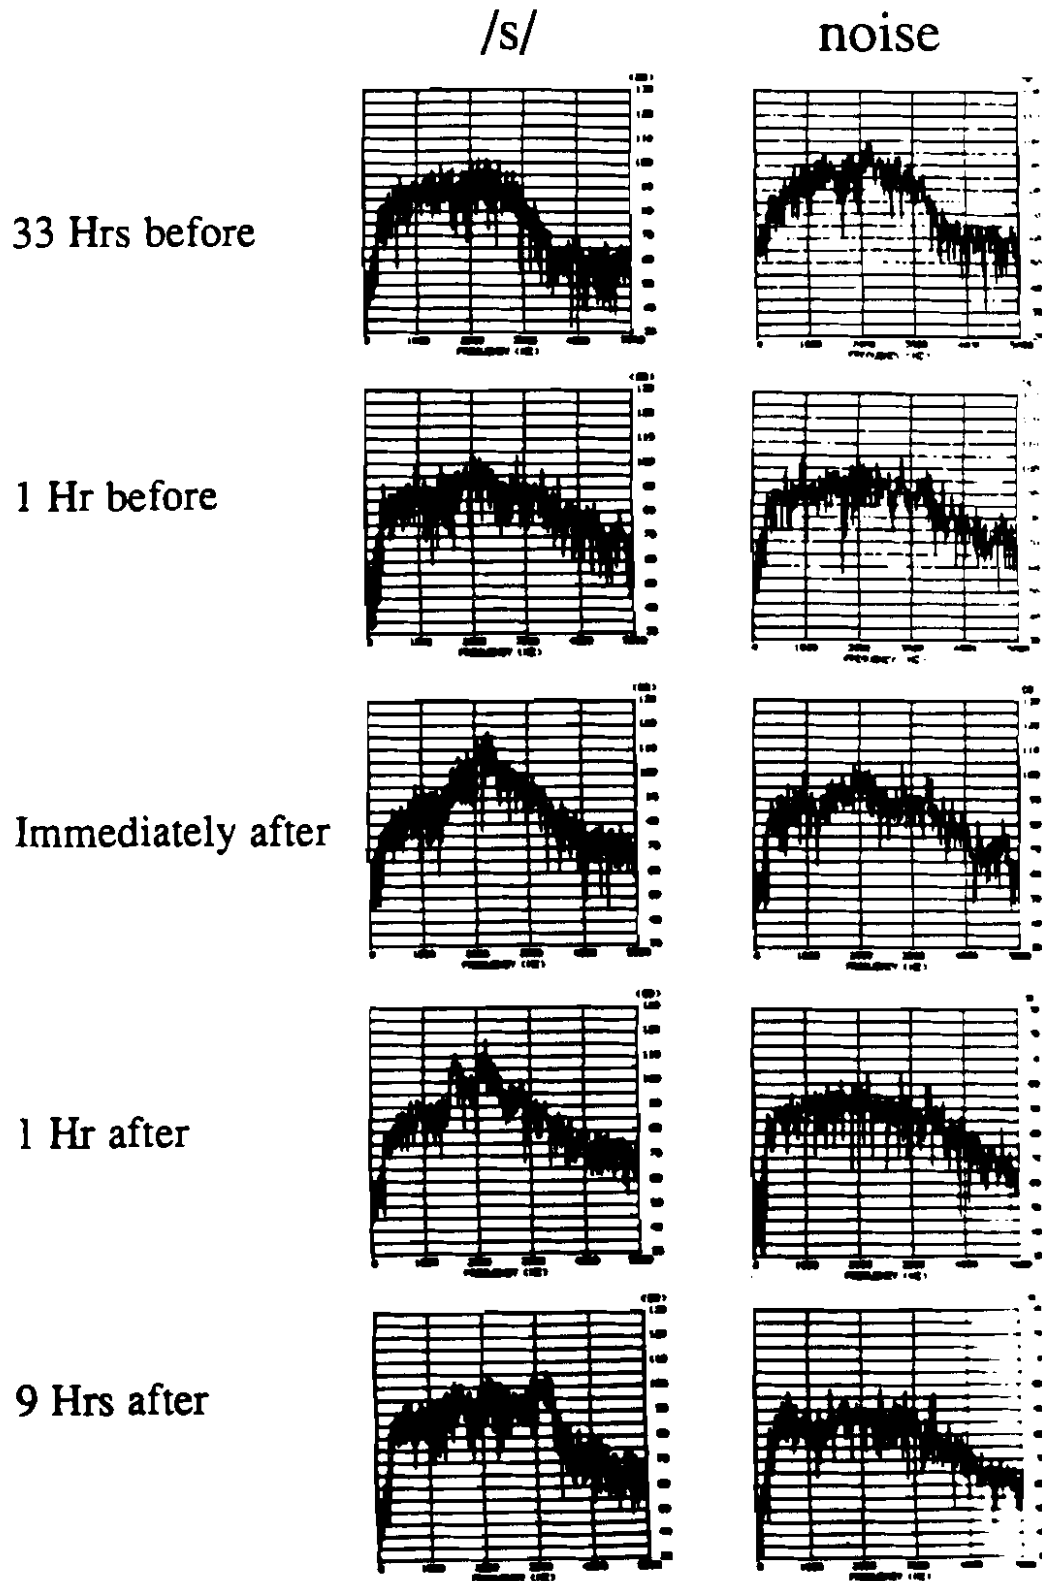
Figure 3. Power spectra of /s/ paired with spectra of nearby open-mike pauses from each of the NTSB recordings.

Figure 3 shows power spectra of the /s/ of *sea* (or *see*) from the five different recordings paired with spectra of background noise from the same recording. The noise spectra were taken from nearby, open-mike background noise. On average the noise segments were 1.3 seconds from the /s/ segments⁸. The /s/ spectrum from the earliest recording (33 hours before the accident) has the same basic shape that the background noise has, suggesting that the /s/ is buried beneath the noise, or more accurately, that the main spectral energy for /s/ is not within the frequency range of the transmission system. The same is true for the /s/ of *sea* recorded one hour before the accident. The spectra of /s/ from the recordings made immediately after the accident and one hour after the accident have peaks of energy (relative to the background noise) in the region from 2000 to 3000 Hz. Finally, the spectrum of /s/ recorded 9 hours after the accident does not have a peak of energy in the region from 2000 to 3000 Hz. We interpret the peaks in the /s/ spectra from samples recorded immediately before the accident and one hour after the accident as evidence for a segmental change from /s/ to /sh/. There is no evidence in these spectra, nor in the other /s/ spectra which we examined, for this segmental change between the earliest recording and the one made one hour before the accident. These spectral changes reflect a change in the articulation of /s/ which has been observed in earlier studies of the effects of alcohol on speech production (Lester & Skousen, 1974; and Trojan & Kryspin-Exner, 1968).
